HISTORIC PRESERVATION CERTIFICATION
APPLICATION—PART 1

1. Name of property: 1720 West Lexington StreetAddress of property: 1720 West Lexington StreetCity Baltimore County _____ State Maryland Zip Code 21223Name of historic district in which property is located: Franklin Square Historic District

CONTINUATION SHEET FOR:
1720 WEST LEXINGTON ST., BALTIMORE, MD. 21223
FRANKLIN SQUARE HISTORIC DISTRICT
HISTORIC PRESERVATION CERTIFICATION APPLICATION-PART 1

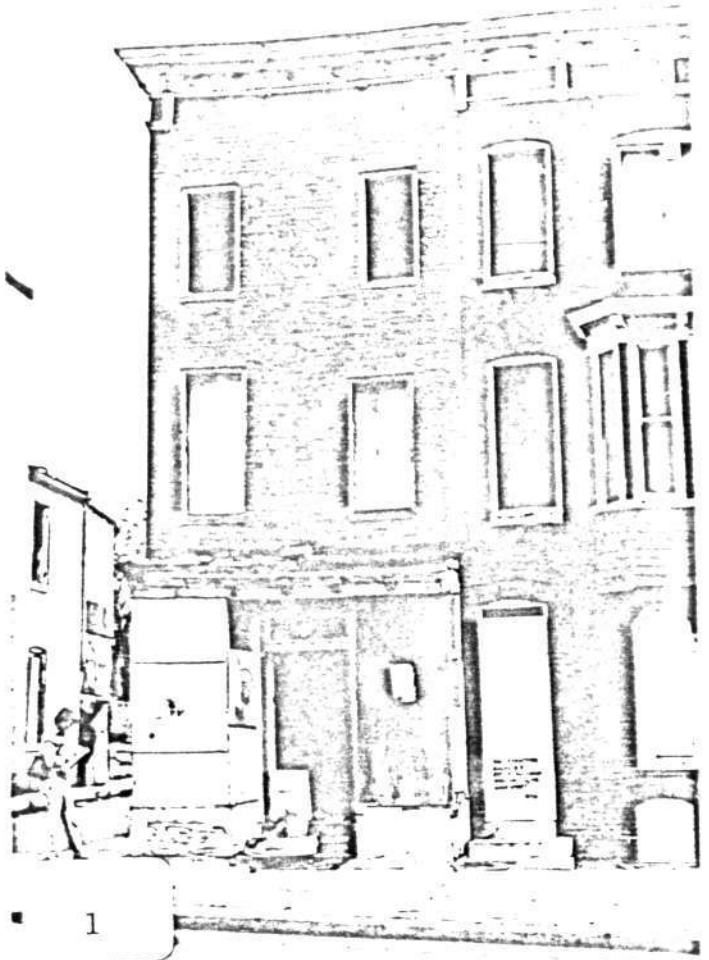
See photographs 1, 2, 3 and 4.

2. cornice. There is also decorative trim across the storefront windows. The interior of the house has been badly damaged by fire. No windows, doors and little trim remain in the house. There are two fireplaces with no mantles. The stairway and banisters have been badly burned and charred.

3. Although no windows remain in the house the exterior trim in the front and side remain intact. There is some usable trim and casing in the front, however, the rear has been badly damaged by fires. There were two fireplaces in the house, however, the mantles no longer remain. It appears there was a frame addition on the rear as can be seen by the two doors on the second and third floor doors which has been removed or burned down. Further, jack arches highlight the second and third story windows in the front.
